# Higher Biscovillack, Treverbyn, Cornwall

*Heritage Impact Assessment*

#### **Executive Summary**

*This report presents the results of a heritage impact assessment for a proposed wind turbine (135m to tip) at Higher Biscovillack, St Mewan, Cornwall. The site is located towards the southern side of the Hensbarrow granite uplands within China clay country.*

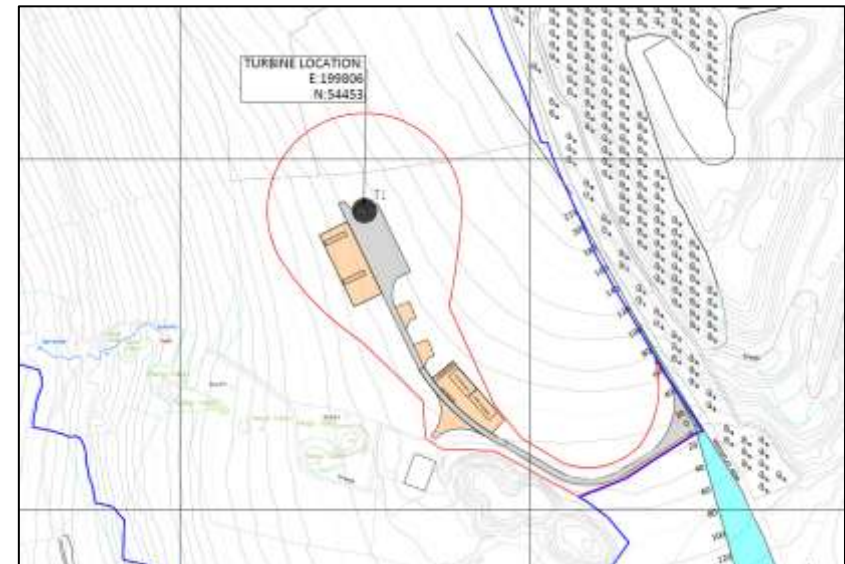
FIGURE 2: PLANS FOR THE TURBINE AND ASSOCIATED INFRASTRUCTURE (SUPPLIED BY THE AGENT).

The proposals are for a single wind turbine with access track, areas of hardstanding, and infrastructure. The wind turbine would be a Vestas V117, 135m to tip, hub/nacelle height of 76.5m, and a 117m diameter rotor.

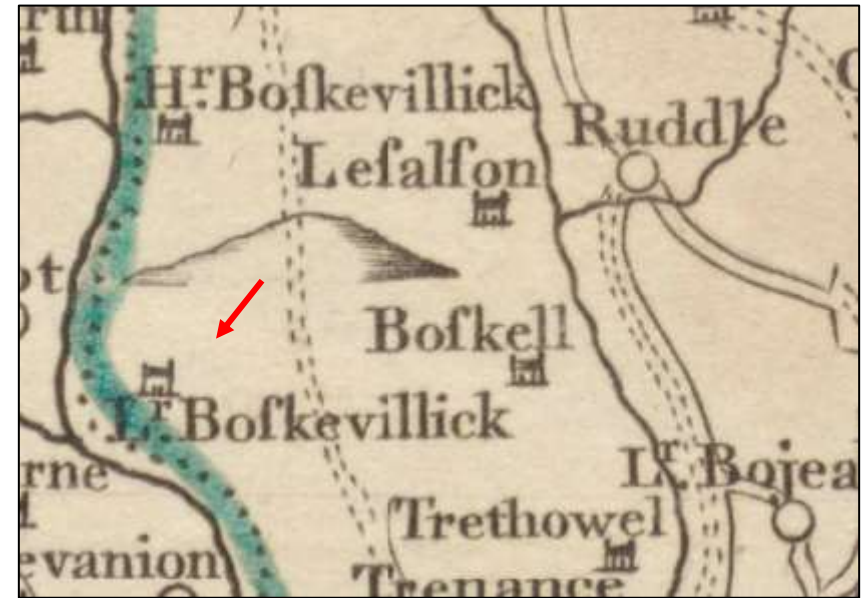
The first available map to depict the site and surrounding area is the 1748 Martyn Map. It does not depict field boundaries or detail within the landscape but provides a schematic layout of the county showing major settlements and estates. Farmhouses are shown at Higher and Lower Boskevillick [Biscovillack] at this date with a road running north-south across unenclosed land depicted to the east.

FIGURE 3: EXTRACT FROM THE 1748 MARTYN MAP (HARVARD). THE APPROXIMATE SITE LOCATION IS INDICATED.

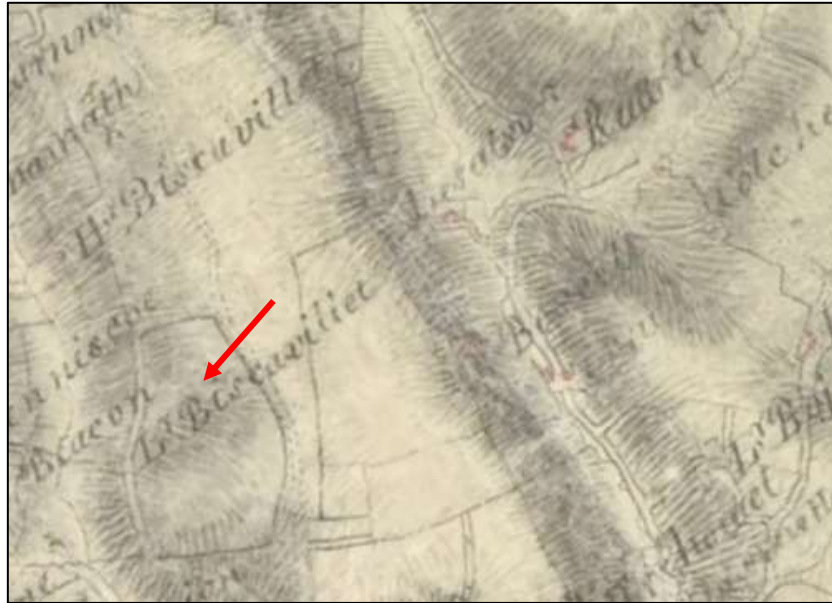
The 1811 surveyors draft map for Grampound shows a little more detail than the earlier Martyn Map, providing an approximate indication of enclosure in the form of field boundaries (although schematic rather than accurate). Higher and Lower Boscavillet [Boscovillack] are depicted with an indication of an enclosure

boundary around Lower Biscavilliet and some further enclosure of the land to the east indicated. The unenclosed road shown on the earlier Martyn Map is also shown on this map.

FIGURE 4: EXTRACT FROM THE 1811 SURVEYORS DRAFT MAP FOR GRAMPOND. THE APPROXIMATE SITE IS INDICATED (BL)

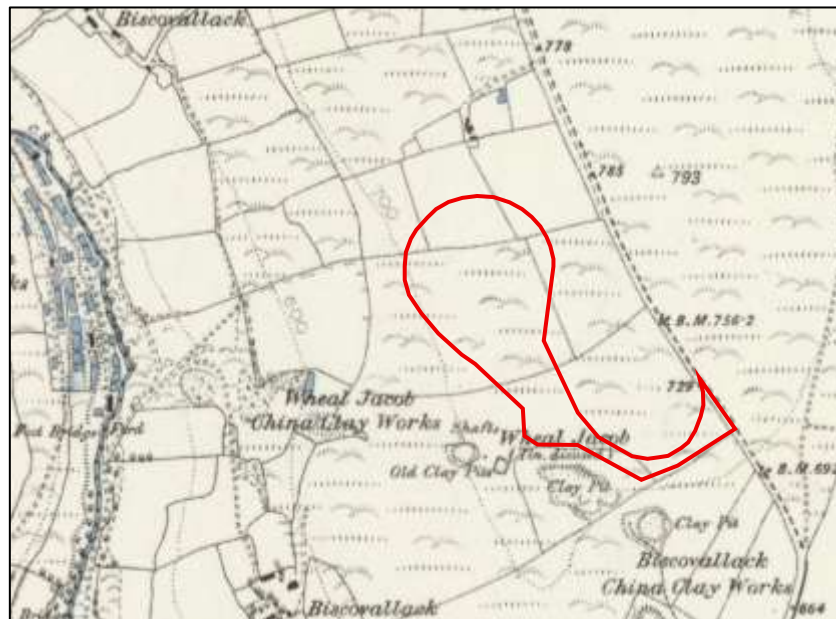
The Ordnance Survey First Edition 6-Inch Map shows little change within the landscape around the site between the mid to late 19<sup>th</sup> century, the southern fields comprising the site depicted as rough ground on this map. The extent of china clay extraction and processing is visible in this landscape to the west of the site and within the southern field in which part of the site lies, Wheal Jacob is depicted as both a disused tin mine and a china clay works, with a number of clay pits shown.

FIGURE 6: EXTRACT FROM THE 1879-81 ORDNANCE SURVEY FIRST EDITION 6-INCH MAP (REPRODUCED WITH PERMISSION OF THE NATIONAL LIBRARY OF SCOTLAND). THE APPROXIMATE SITE LOCATION IS INDICATED.

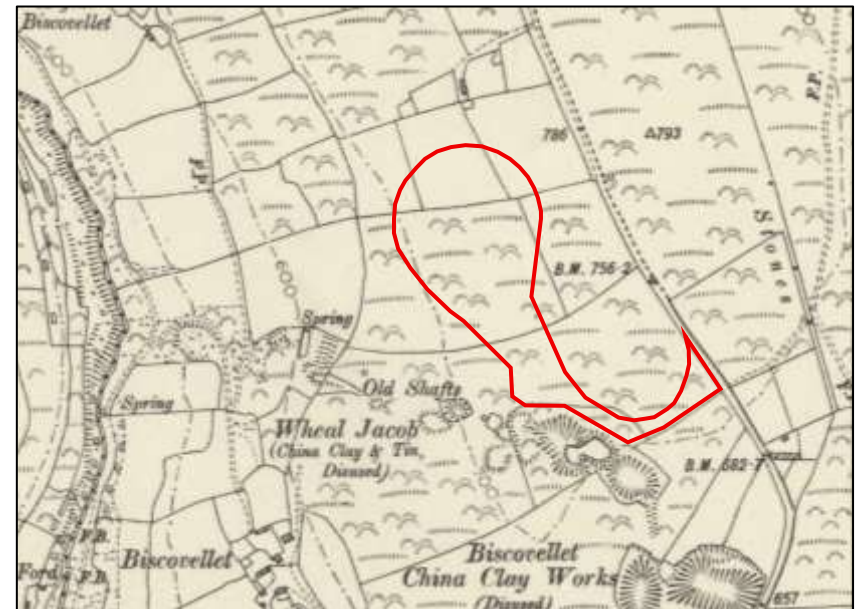
The 1906 Ordnance Survey Second Edition 6-Inch Map shows much the same landscape as the earlier First Edition map, with some extension in the china clay pits to the south of the site, although by 1906 these are marked as disused. This map names the site as Biscovellet rather than Biscovallack, shown on the First Edition map. A line of boundary stones are marked on Trenance Downs, to the east of the site. The only notable changes on subsequent Ordnance Survey maps is the subdivision of the northern fields comprising part of the site in the mid 20<sup>th</sup> century and the loss of a number of boundaries within the site by the later 20<sup>th</sup> century.

FIGURE 7: EXTRACT FROM THE 1906 ORDNANCE SURVEY SECOND EDITION 6-INCH MAP (REPRODUCED WITH PERMISSION OF THE NATIONAL LIBRARY OF SCOTLAND). THE APPROXIMATE SITE LOCATION IS INDICATED.

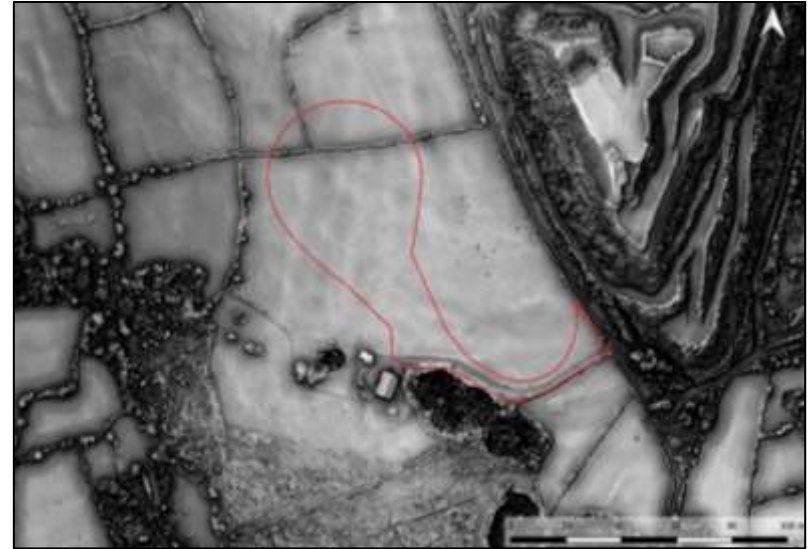
FIGURE 13: LIDAR 1M DSM ARCHAEOLOGICAL VAT COMBINED PROCESSED USING QGIS 3.40 AND RVT PLUGIN. CONTAINS ENVIRONMENT AGENCY DATA USED UNDER THE OPEN GOVERNMENT LICENSE 3.0.

Digital Surface Model (DSM) and Digital Terrain Model (DTM) LiDAR data has been processed and examined for the site, with both data sets showing little evidence to suggest the presence of archaeological features. The LiDAR data indicates undulations in the ground surface which are likely to be of geological origin although it is also evident that the site has been extensively ploughed. A former field pattern is visible just to the north west of the site area and it is possible that if this extended across the site area, any upstanding evidence for this has been removed by modern agricultural activity.

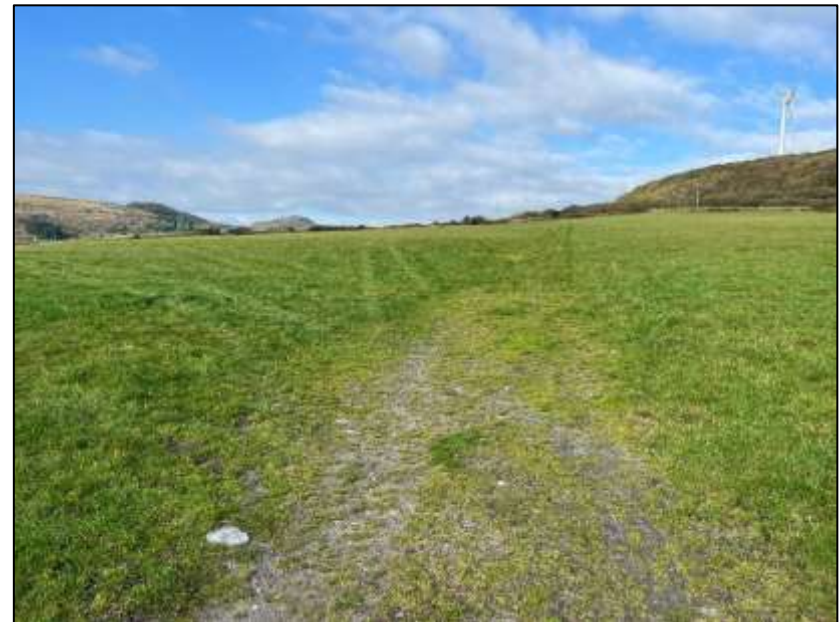
FIGURE 15: FIELD F1, VIEW ACROSS THE PROPOSAL SITE FROM THE SOUTH-SOUTH-WEST (NO SCALE).

The site was under short grass at the time of survey and the ground was generally firm under foot. The site was situated on a south-west facing slope, the gradient of which increased significantly towards the western edge of the survey area, whilst the road beyond the eastern boundary ran along the crest of a hill within what has become an increasingly industrial landscape. The site was bordered by agricultural fields to the north and to the west, whilst enclosed rough ground was noted to the south. The landscape to the east was dominated by Greensplat Quarry, though the visual impact of the quarry was softened by dense vegetation growth, whilst views to the west overlooked agricultural fields and Blackpool Pit beyond. The site was accessed via a long access track that adjoined the main road to the east; the access track skirted the southern boundary before terminating at a yard area, from which the field was accessed via a gate in the southern boundary. The access track lies within the red line boundary, though it was not subject to magnetometry survey given that it was formed of a hard and compacted surface. A former quarry was noted beyond the southern boundary, presumably a part of Wheal Jacob/Biscovellet China Clay Works, though it is now largely overgrown and it is somewhat obscured by the post-and-wire fence and the unkempt hedge that define the southern boundary of the access track.

The northern boundary was the most substantial of the four boundaries, comprising an earthwork bank with large blocks of natural stone that were possibly collected during the clearance of the site prior to its reclamation for agricultural purposes. It measured c.1.5m in height and c.1.0m in width and it was in good condition along much of its length, though it had collapsed in places. A post-and-wire fence ran atop the western part of the boundary and along the eastern part of the boundary, whilst disparate patches of vegetation were noted along the length of the boundary. The eastern boundary appeared to be similar in character and in form to the northern boundary, with a post-

and-wire fence that ran along the entire length of the boundary, though it was covered in much denser grass and vegetation and blocks of natural stone were only infrequently noted. The southern boundary comprised a largely unvegetated post-and-wire fence, towards the centre of which was the main access gate, whilst the western boundary comprised a large and uncut area of dense vegetation. The southern boundary and the western boundary were both relatively low which, coupled with the topography of the site, allowed for clear views across much of the landscape to the west. There was no clear evidence for earthwork features at the time of the walkover survey despite the known presence of historic boundaries.

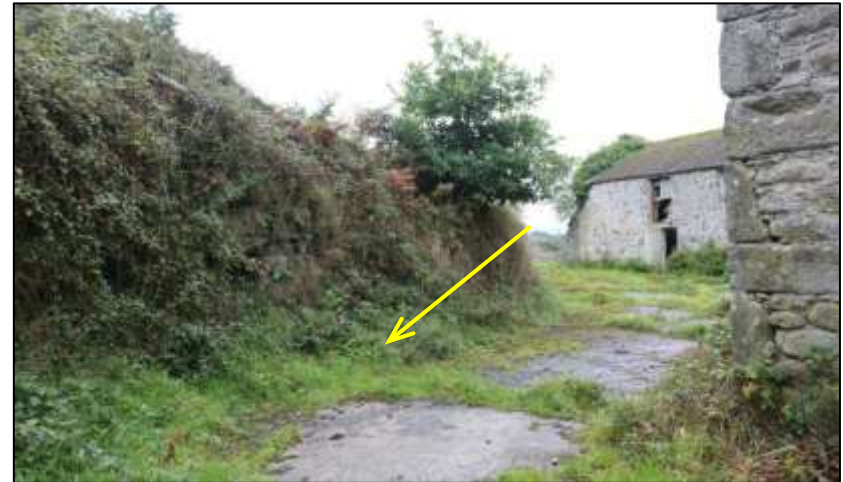
<p><i>Landscape Presence:</i> None.</p>
<p><i>Sensitivity of Asset:</i> The asset is not sensitive to views due to the nature of its subterranean build; however, the farmstead and setting of the asset is affected as there are views to the site of the proposed turbine. The rarity of the asset could be considered to increase its sensitivity to any change either directly or indirectly.</p>
<p><i>Contribution of Setting to Significance of Asset:</i> Irrelevant. This is a functional store or similar which relates to the use of the site as a historic farm holding. Considerations of setting beyond the limits of its immediate vicinity are irrelevant to its significance.</p>
<p><i>Scale of Change:</i> The proposed turbine would be visible from the farmyard, subject to screening, but not from the crow. The location is close enough (c.500m) for the turbine to be potentially audible.</p>

FIGURE 18: THE CROW (INDICATED) AT HIGHER BISCOVILLACK FARM; VIEWED FROM THE NORTH.

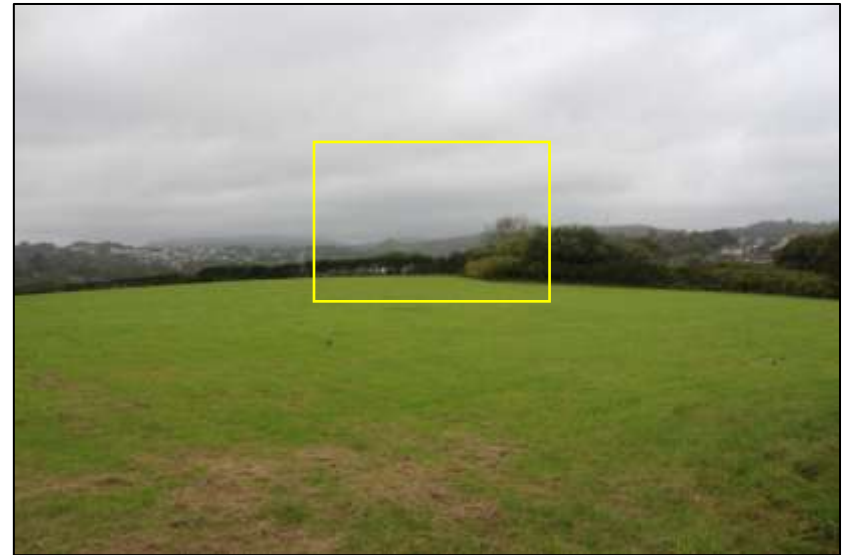
FIGURE 19: THE VIEW ACROSS ST AUSTELL TO THE DOWNS FROM AN ELEVATED POSITION TO THE SOUTH-EAST.

THE VIEW ACROSS ST AUSTELL TO THE DOWNS FROM AN ELEVATED POSITION TO THE SOUTH-EAST. THE PROPOSED TURBINE WOULD BE LOCATED JUST LEFT OF CENTRE. DISTANCE TO TURBINE: C.3.5KM.

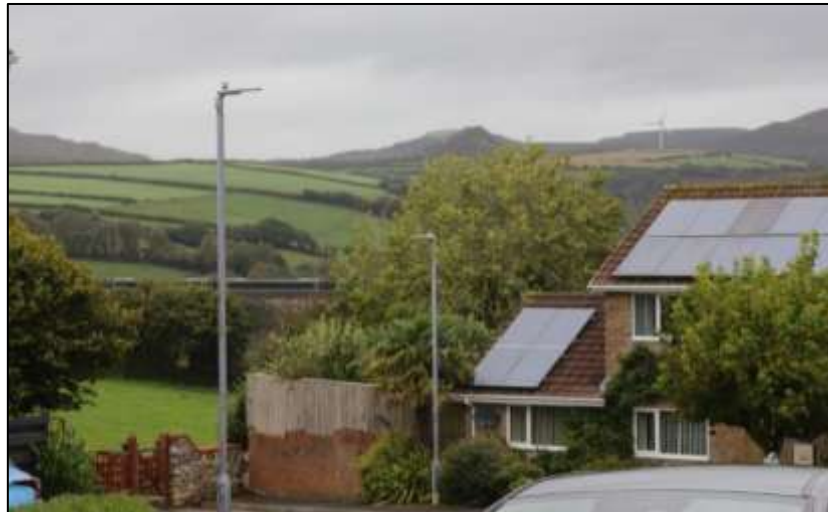
<p><i>Principal Views:</i> Up to the viaduct from below, and from along the valley to the north and south.</p>
<p><i>Landscape Presence:</i> This is a large and imposing structure within the Gover Valley, but as it straddles the valley it is not visible from the east and west and is partly concealed by trees. Furthermore, built at a bend in the river valley long views are restricted.</p>
<p><i>Sensitivity of Asset:</i> This asset is defined by its scale but is actually quite a recessive feature in the landscape. Impressive but functional.</p>
<p><i>Contribution of Setting to Significance of Asset:</i> Incidental. The viaduct now appears to float above a sea of trees, an attractive piece of 19<sup>th</sup> century railway infrastructure. This is very much at odds with an original setting dominated by China clay dries and other processing works.</p>
<p><i>Scale of Change:</i> The proposed turbine would be located to the north, towards the head of the Gover Valley, away and in front of the operational turbines. There is likely to be some cumulative impact, however most meaningful views to the viaduct (i.e. from below, and from the south-east and north) would not feature the proposed turbine to any significant degree and the immediate setting of the viaduct would be unaffected.</p>

FIGURE 23: GOVER RAILWAY VIADUCT (WITH TRAIN), THE EXTANT GOONAMARTH TURBINE TO THE RIGHT IN THE BACKGROUND; VIEWED FROM LOWER WOODSIDE TO THE SOUTH-EAST.

GOVER RAILWAY VIADUCT (WITH TRAIN), THE EXTANT GOONAMARTH TURBINE TO THE RIGHT IN THE BACKGROUND; VIEWED FROM LOWER WOODSIDE TO THE SOUTH-EAST. THE PROPOSED TURBINE WOULD BE LOCATED BEYOND BUT BETWEEN THE TWO VEGETATED SKY TIPS TO RIGHT OF CENTRE. DISTANCE TO TURBINE: C.1.8KM.

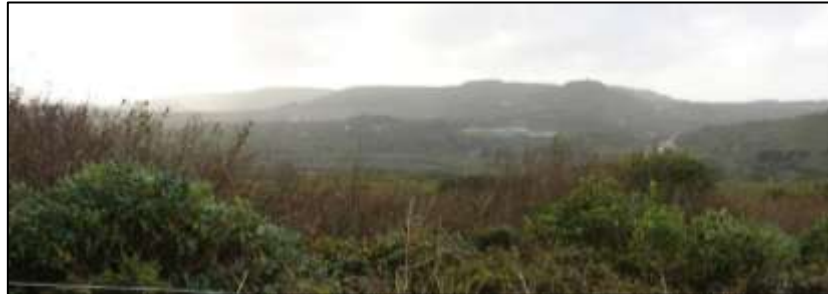
<i>Contribution of Setting to Significance of Asset:</i> The China clay landscape is defined by geology; the setting is therefore the very reason for its existence. The surviving fragments of earlier historic landscapes within the current and 19 <sup>th</sup> century China clay district lend an important chronological 'sense of place' within the wider narrative of Cornwall.
<i>Scale of Change:</i> The proposed turbine would be located NNW of the Biscovellet sky-tip, on higher ground behind the sky tip. It would introduce another tall vertical feature into this landscape to compete with the conical sky tips. This would have an appreciable effect on a skyline of the southern part of the China clay landscape. The other two sky tips would not have this relationship but would still be affected more generally by the slight cumulative increase in modern features in this landscape.
<i>Significance of Effect:</i> Medium value + Minor change = Slight effect

FIGURE 26: THE CHINA CLAY LANDSCAPE, VIEWED FROM CARLOGGAS TO THE NORTH-EAST.

THE CHINA CLAY LANDSCAPE, VIEWED FROM CARLOGGAS TO THE NORTH-EAST. THE PROPOSED TURBINE WOULD BE LOCATED TO THE EXTREME LEFT OF THE PHOTOGRAPH. DISTANCE TO TURBINE: C.3KM.

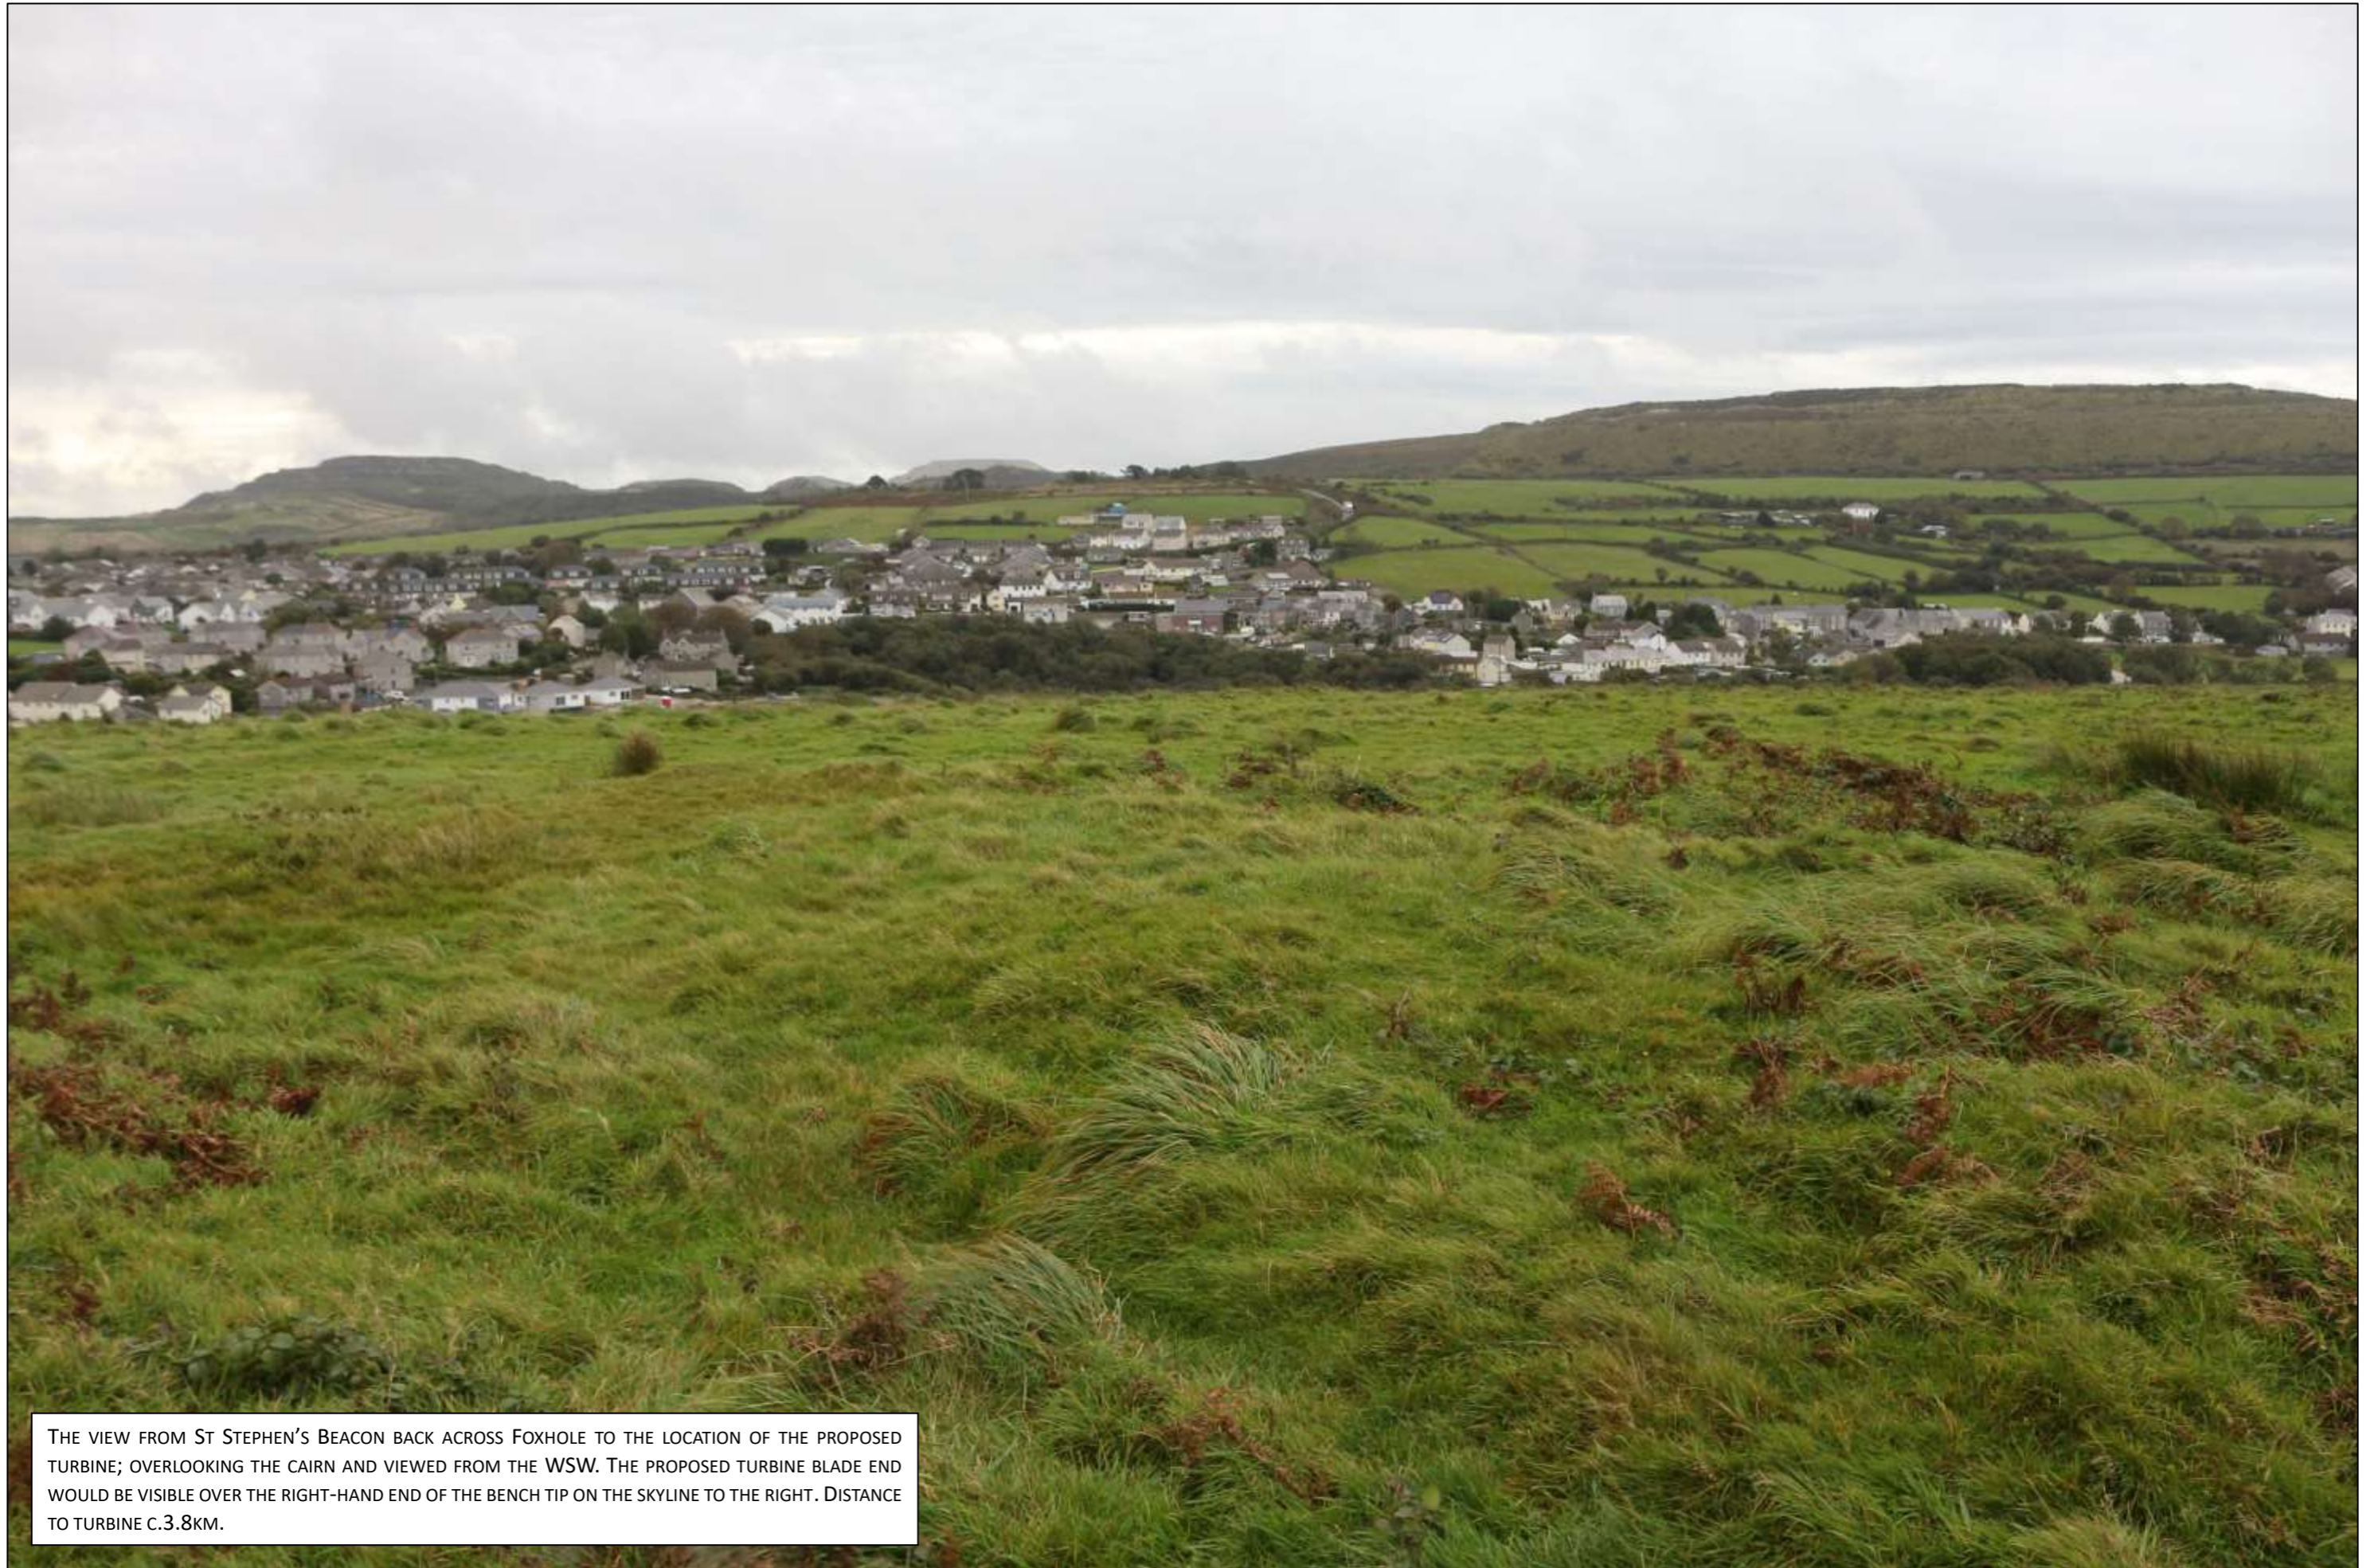
THE VIEW FROM ST STEPHEN'S BEACON BACK ACROSS FOXHOLE TO THE LOCATION OF THE PROPOSED TURBINE; OVERLOOKING THE CAIRN AND VIEWED FROM THE WSW. THE PROPOSED TURBINE BLADE END WOULD BE VISIBLE OVER THE RIGHT-HAND END OF THE BENCH TIP ON THE SKYLINE TO THE RIGHT. DISTANCE TO TURBINE C.3.8KM.

<b>Asset Name:</b> Earlier Prehistoric hillfort and round cairn at St Stephens Beacon	
<i>Parish:</i> St Stephen-in-Brannel	<i>Within the ZTV:</i> No
<i>Designation:</i> SAM	<i>Value:</i> High
<i>Distance to the turbine:</i> 1km	<i>Condition:</i> Fair/Good
<p><i>SAM Text:</i> The monument includes an earlier prehistoric hillfort and round cairn, situated at the summit of the prominent hill called St Stephen's Beacon. The hillfort survives as a roughly oval enclosure surrounding the summit of the hill with an annexe to the north and is defined by a terrace or scarp of up to 7m wide and 2m high which has been partially fossilised in field boundary banks to the south. Other associated ditches, structures, layers, deposits and features will be preserved as buried features. The outer side of the terrace is partially revetted by large stones and marked in places by upright orthostats. The area of the hillfort has been the subject of mineral prospecting, evidenced by numerous pits. First noted in 1864 as being 'distinctly visible' and recorded variously as having between one up to three surrounding ramparts, the hillfort has been variously recorded as being of Neolithic through to Iron Age date. Within the enclosed area on the summit of the hill is a round cairn which was re-used as a beacon. It survives as a low, irregular spread of stones. The cairn was largely dismantled in 1853 when, according to Thomas, it actually measured up to 20m in diameter. The outer stone was removed and used to construct an engine house for Tin Hill Mine and, at this time, a lower platform of stones and a large cist containing ashes was found and left in situ. Its re-use as a beacon is largely inferred from its very prominent position and place-name evidence of 'St Stephen's Beacon', 'Foxhole Beacon' or 'Beacon Hill'.</p>

<p><i>Supplemental Comments:</i> A large site atop a natural hill. The ramparts are visible and quite pronounced in places, overgrown with scrub in others. The site is grazed but there is some animal trample damage. Sweeping open views are possible from</p>

<p>the summit, the monument sitting above the much-altered modern landscape and set apart as a survivor from a relict ancient landscape that is all but lost. Overshadowed by the China clay spoil tips on the other side of Foxhole. Some evidence of antisocial behaviour, with littering and dumping in and around the site, although not on it. Use of the site for mountain biking/scrambling observed previously.</p>
<p><i>Conservation Value:</i> High evidential value. Aesthetic value as an authentic relict archaeological site but built for function as a defensive/enclosed location. Historical value as an example of its type, minor local value of cairn, both for antiquarian excavation and later use as a beacon site. No known communal value.</p>
<p><i>Authenticity and Integrity:</i> The site is authentic as a Scheduled Monument, a Prehistoric enclosed hilltop site. Its banks are upstanding although much weathered and it may seal many significant deposits. The cairn has been affected by the removal of stone and antiquarian excavation. The site could and should be better managed for scrub growth, animal damage and weathering; the integrity of some of its banks is probably at risk if not better managed in the future.</p>
